141 Main Street, East Berlin

1985 Townwide Historic and Architectural Survey of Berlin, Connecticut. Survey # 085

1890 Methodist-Episcopal Parsonage

HISTORIC RESOURCES INVENTORY
BUILDING AND STRUCTURES
 HIST-6 NEW 5/77

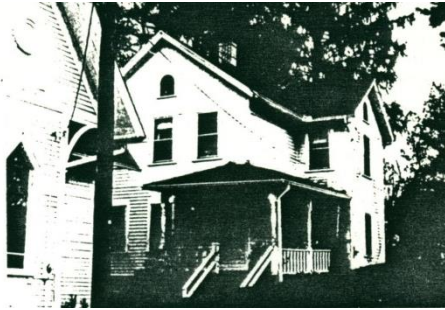
Methodist parsonage (behind the church)

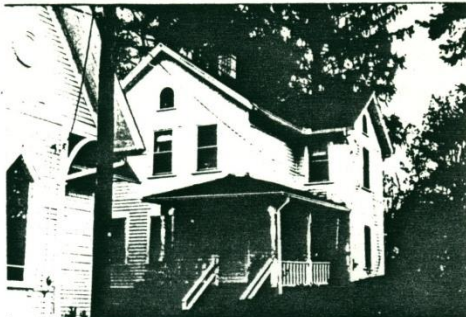
DESCRIPTION (Continued)	17 OTHER NOTABLE FEATURES OF BUILDING OR SITE (interior and/or exterior) <p>The Methodist Episcopal parsonage has a three-bay front-facing gable with right and left gabled ells. The right entry is protected by a one-story shallow-roofed porch with turned posts, simple curved brackets, and a cut-out slat railing resembling turned balusters. The porch covers only the entry bay on the facade and wraps around the right elevation to meet a side entry in the front wall of the right ell. Windows have plain board surrounds and are fitted with 1-over-1 sash. All three main peaks have small round-headed attic lights and modified fishscale shingles.</p>	
	18 ARCHITECT BUILDER
